Examples show how FACE works ...

FEDERALLY
ASSISTED
CODE
ENFORCEMENT

Department of Public Works • City & County of San Francisco

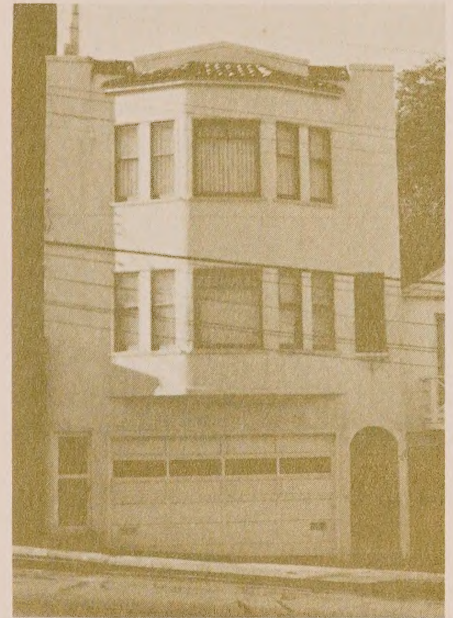
Forty-five year old home with low repair costs

This six-room Richmond District home was well built and maintained. A few code deficiencies were found and corrected with a \$565.00 rehabilitation loan from FACE. A new garage door replaced a dilapidated old one and an electrical branch circuit and additional outlets replaced substandard wiring. The original wiring was no longer adequate to meet the demand of numerous electrical appliances used in this home today.

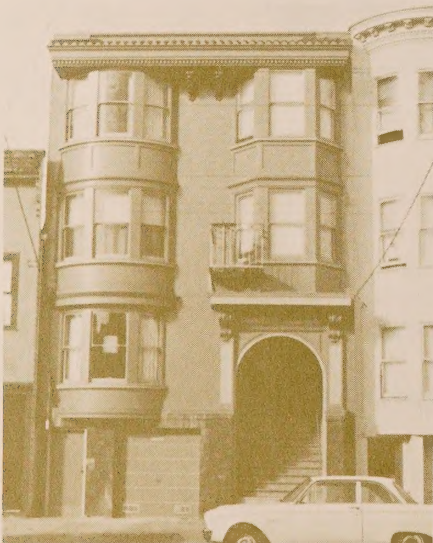
The building sat vacant several years before the owner-contractor began the restoration with a \$24,600 loan. Fires had rendered the place unlivable, but the structural shell was sound. The re-

habilitation work included all new water piping, water heaters, drainage, gas lines, electricity, heat, totally remodeled kitchens and baths, replacement of almost all wall surfaces, repainting inside and out, lowered ceilings in two units, carpeting throughout all rooms except kitchens and baths, fire proofing of the lobby and provision of a fire extinguisher, repair and replacement of all broken and unfunctioning windows and construction of new front and rear stairs.
